**Flood Control Project Maintenance
Levee Inspections**
LMA District Cover Sheet
Spring 2015 Levee Inspection Results

Reclamation District No. 1600 Mull

Spring 2015 Levee Inspection Results

Waterway			Bank	Unit Miles
Unit No. 01 Sacramento River			Right	10.46
	Spring (March - May)	Summer (June - August)	(September - November) Fall	Winter (December - February)
Unit Maintenance Rating (Fall Only)				
Date of Inspection	03/24/2015 - 03/24/2015			
DWR Inspector	Jai Lor			
Accompanied By

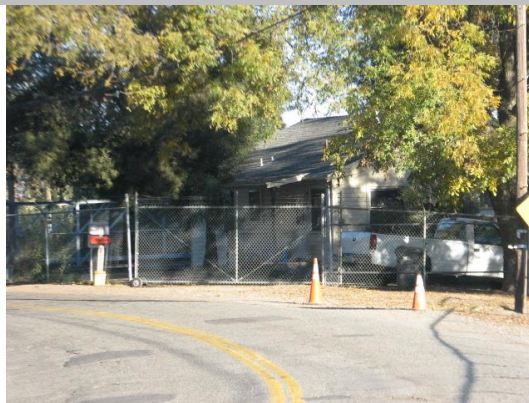
Photo 1 of 1 : SP_2015_RD1600_191_1_20150324_00001.jpg

The caretakers home for the operator of the pumping plant (RD 2035).
Fall 2013

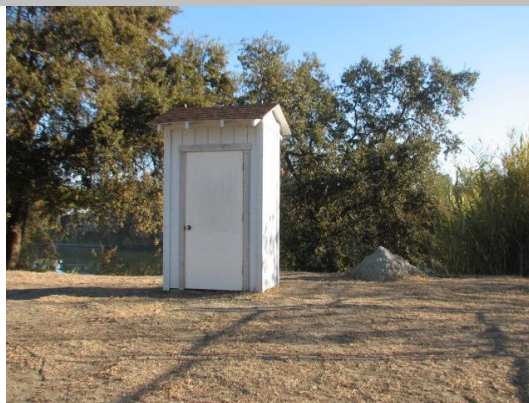
Photo 1 of 1 : SP_2015_RD1600_191_129_20150324_00039.jpg

LM Start	0.10	Rating **	M	Issue No.	129
LM End	0.10	Issue Type +	En	Location *	WS
Category	Earthen Levee			GPS Latitude/Longitude	
				Start	End
Item	Encroachments			38.676467 °	38.676467 °
				-121.631217 °	-121.631217 °
DWR ID	DWR_RD1600_01_f _ 2013_129				
Action/Comments					
Building Inspector Comments: This is a well pump house. It is potable water for the house and pumping plant.

The small building is a pump house for the well. It services the house with water. Fall 2013

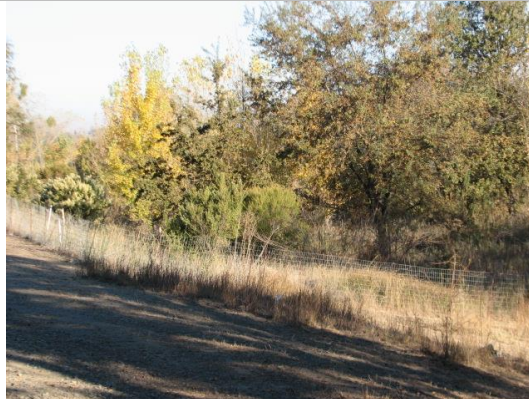
Photo 1 of 2 : SP_2015_RD1600_191_49_20150324_00037.jpg

The revegetation area is fenced off but nobody has been caring for it.
Fall 2013

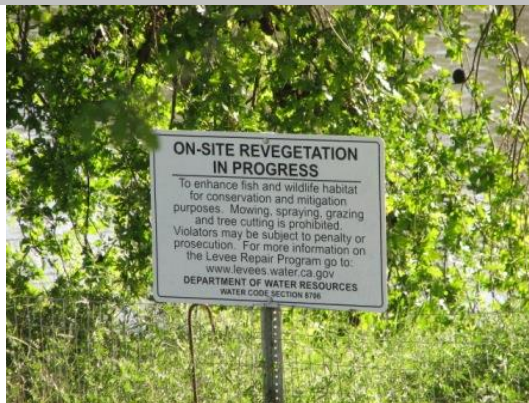
Photo 2 of 2 : SP_2015_RD1600_191_49_20150324_00038.jpg

LM Start	0.10	Rating **	A/W	Issue No.	49 (cont)
LM End	0.23	Issue Type +	Ob	Location *	WS

Revegetation site. Photo taken spring 2012.

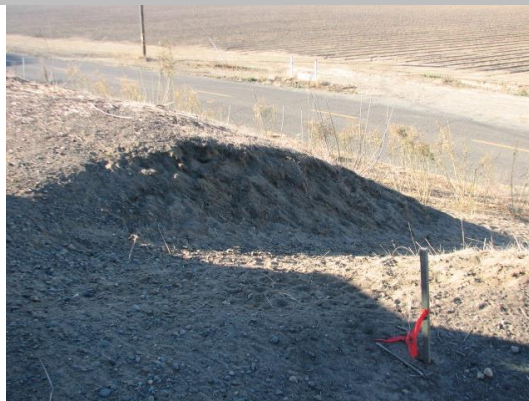
Photo 1 of 1 : SP_2015_RD1600_191_133_20150324_00040.jpg

LM Start	0.53	Rating **	M	Issue No.	133
LM End	0.53	Issue Type +	Ma	Location *	LS
Category	Earthen Levee			GPS Latitude/Longitude	
				Start	End
Item	Erosion / Bank Caving			38.682140 °	38.682140 °
				-121.634083 °	-121.634083 °
DWR ID	DWR_RD1600_01_f_2013_133				
Action/Comments					
Schedule repair of erosion site prior to the next inspection.

The erosion on the landside shoulder is caused by foot traffic. Fall 2013

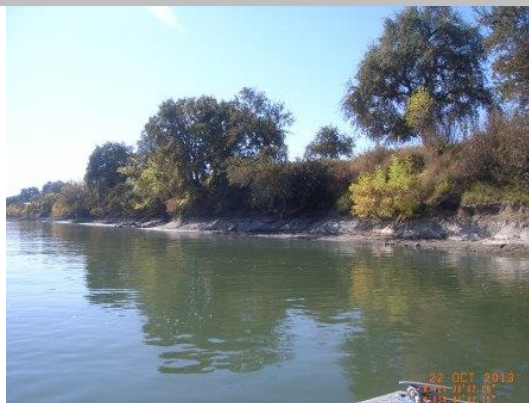
Photo 1 of 1 : SP_2015_RD1600_191_6_20150324_00007.jpg

LM Start	0.56	Rating **	M	Issue No.	6
LM End	0.66	Issue Type +	Ma	Location *	WS
Category	Supplemental			GPS Latitude/Longitude	
				Start	End
Item	USACE Erosion Survey			38.682707 °	38.684106 °
				-121.633830 °	-121.634219 °
DWR ID	DWR_RD1600_01_f_2014_6				
Action/Comments					
Inspector Comments: 2000 - Very cohesive vertical bank. 2003 - Some minor new erosion. 2006 - Some minor erosion in old pockets. 2009 - Minimal new erosion. 2011 - Multiple new erosion pockets and a few new tree popouts. 2013: No observed changes. [2013 Site ID: SAC_71-3_R]

USACE 2013 Photo #1

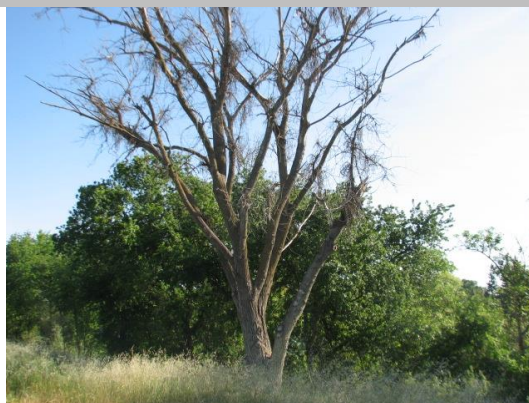
Photo 1 of 1 : SP_2015_RD1600_191_624_20150324_00048.jpg

LM Start	0.78	Rating **	A/W	Issue No.	624
LM End	0.78	Issue Type +	Ma	Location *	WS
Category	Earthen Levee			GPS Latitude/Longitude	
				Start	End
Item	Vegetation			38.685713 °	38.685713 °
				-121.634985 °	-121.634985 °
DWR ID	DWR_RD1600_01_s_2015_624				
Action/Comments					
Trees / Woody Vegetation

The tree is dying and needs to be monitored so there is no threat to the levee. Spring 2014

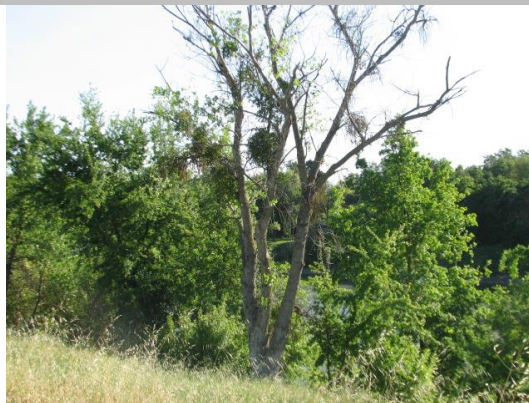
Photo 1 of 1 : SP_2015_RD1600_191_625_20150324_00049.jpg

The tree is dying and needs to be monitored so there is no threat to the levee. Spring 2014

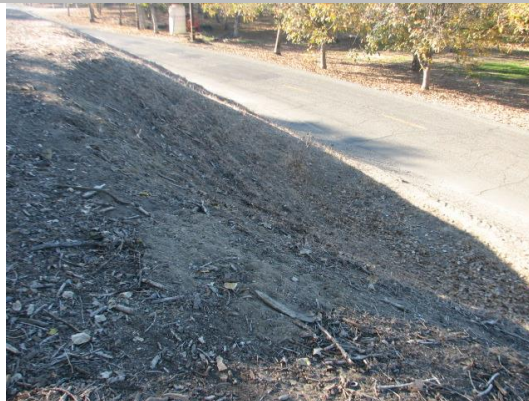
Photo 1 of 1 : SP_2015_RD1600_191_134_20150324_00041.jpg

LM Start	0.97	Rating **	M	Issue No.	134
LM End	0.97	Issue Type +	Ma	Location *	LS
Category	Earthen Levee			GPS Latitude/Longitude	
				Start	End
Item	Slope Stability			38.688454 °	38.688454 °
				-121.635528 °	-121.635528 °
DWR ID	DWR_RD1600_01_f_2013_134				
Action/Comments					
Repair slope instability.

The levee has a deep depression caused by slope stability. Fall 2013

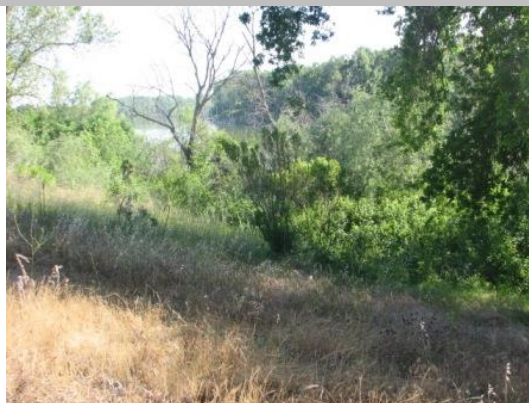
Photo 1 of 2 : SP_2015_RD1600_191_22_20150324_00022.jpg

LM Start	1.01	Rating **	A/W	Issue No.	22
LM End	1.09	Issue Type +	Ma	Location *	WS
Category	Earthen Levee			GPS Latitude/Longitude	
				Start	End
Item	Vegetation			38.689078 °	38.690267 °
				-121.635605 °	-121.635650 °
DWR ID	DWR_RD1600_01_s_2012_22				
Action/Comments					
Environmental Requirements.

The revegetation site along the berm and shoulder of the river.

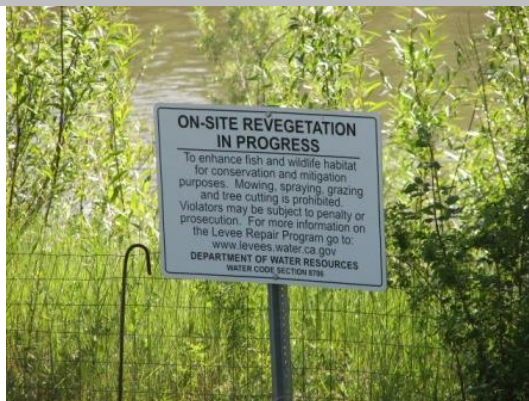
Photo 2 of 2 : SP_2015_RD1600_191_22_20150324_00023.jpg

Revegetation site. Photo taken spring 2012.

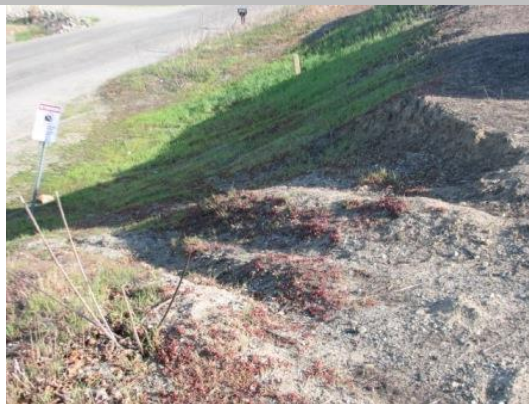
Photo 1 of 2 : SP_2015_RD1600_191_4_20150324_00003.jpg

LM Start	1.39	Rating **	M	Issue No.	4
LM End	1.39	Issue Type +	Ma	Location *	LS
Category	Earthen Levee			GPS Latitude/Longitude	
				Start	End
Item	Erosion / Bank Caving			38.694395 °	38.694395 °
				-121.634376 °	-121.634376 °
DWR ID	DWR_RD1600_01_f_2012_4				
Action/Comments					
Schedule repair of erosion site prior to the next inspection.					
Inspector Comments: Damage looks like caused by vehicles.

Erosion from vehicles on levee slope. Spring 2013

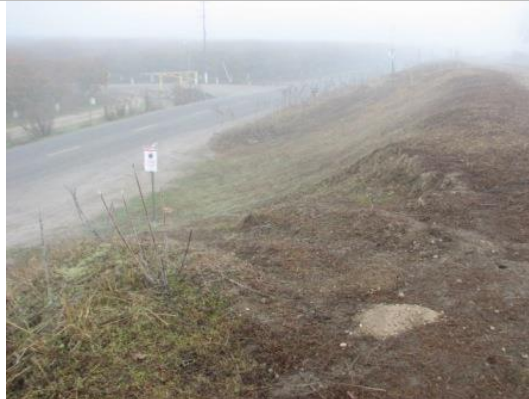
Photo 2 of 2 : SP_2015_RD1600_191_4_20150324_00004.jpg

LM Start	1.39	Rating **	M	Issue No.	4 (cont)	
LM End	1.39	Issue Type +	Ma	Location *	LS	
Category	Earthen Levee			GPS Latitude/Longitude		
				Start		End
Item	Erosion / Bank Caving			38.694395 °	38.694395 °	
				-121.634376 °	-121.634376 °	
DWR ID	DWR_RD1600_01_f_2012_4					
Action/Comments						
Schedule repair of erosion site prior to the next inspection.						
Inspector Comments: Damage looks like caused by vehicles.

Vehicles and people have created some erosion on the levee. Fall 2012

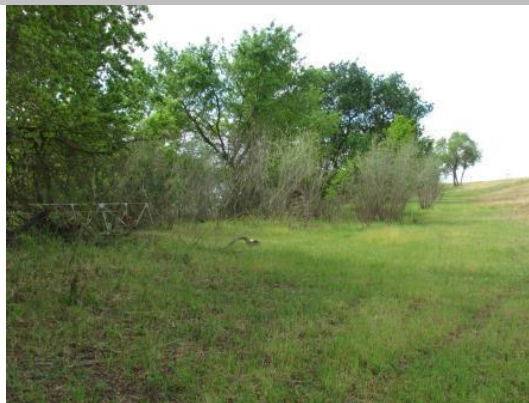
Photo 1 of 1 : SP_2015_RD1600_191_626_20150326_00253.jpg

View of debris on the waterward side of the levee looking downstream. Spring 2015.

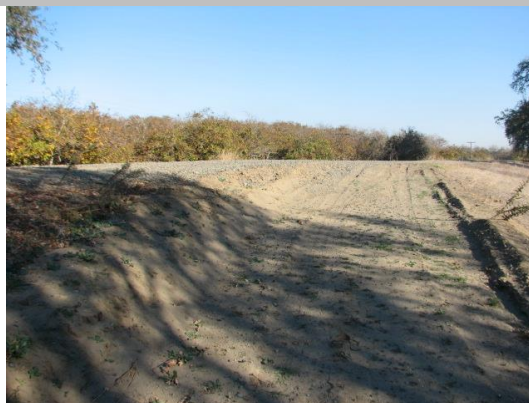
Photo 1 of 2 : SP_2015_RD1600_191_137_20150324_00043.jpg

LM Start	1.76	Rating **	M	Issue No.	137
LM End	1.76	Issue Type +	Ma	Location *	WS
Category	Earthen Levee			GPS Latitude/Longitude	
				Start	End
Item	Crown Surface / Depressions / Rutting			38.699130 °	38.699130 °
				-121.631300 °	-121.631300 °
DWR ID	DWR_RD1600_01_f_2013_137				
Action/Comments					
Repair depressions or ruts in the crown or slope.

A look at the cut done by the dozer. Fall 2013

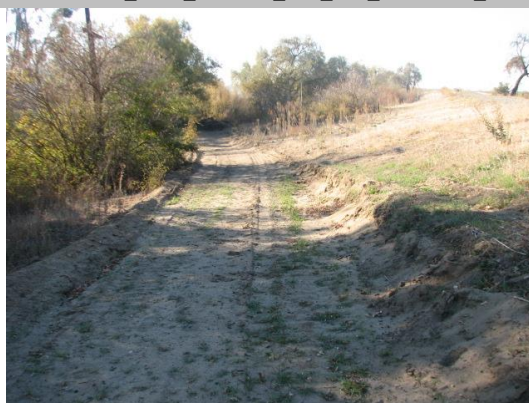
Photo 2 of 2 : SP_2015_RD1600_191_137_20150324_00044.jpg

It appears that a dozer has pushed a pile of brush to the waters edge.
Fall 2013

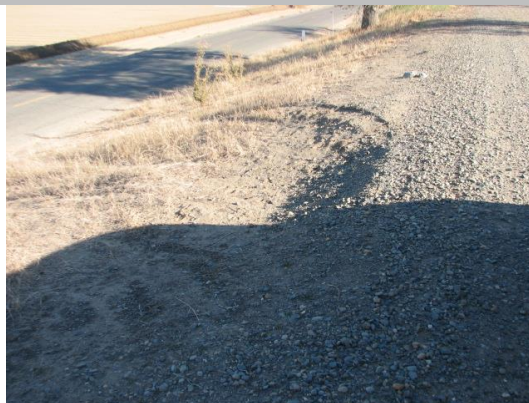
Photo 1 of 1 : SP_2015_RD1600_191_143_20150324_00047.jpg

LM Start	2.40	Rating **	M	Issue No.	143
LM End	2.40	Issue Type +	Ma	Location *	LS
Category	Earthen Levee			GPS Latitude/Longitude	
				Start	End
Item	Slope Stability			38.705152 °	38.705152 °
				-121.622190 °	-121.622190 °
DWR ID	DWR_RD1600_01_f_2013_143				
Action/Comments					
Repair slope instability.

The levee slope appears to have slipped at the shoulder. Fall 2013

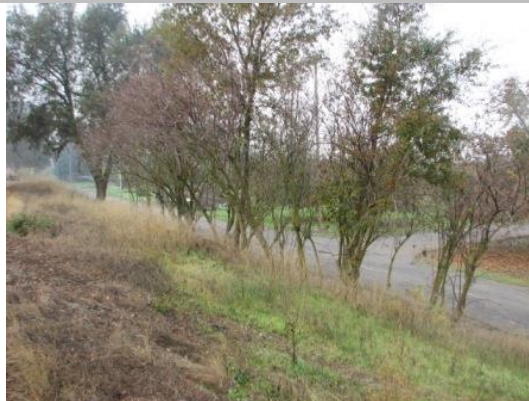
Photo 1 of 1 : SP_2015_RD1600_191_37_20150324_00034.jpg

A large stand of elderberries on the landside slope. Fall 2012

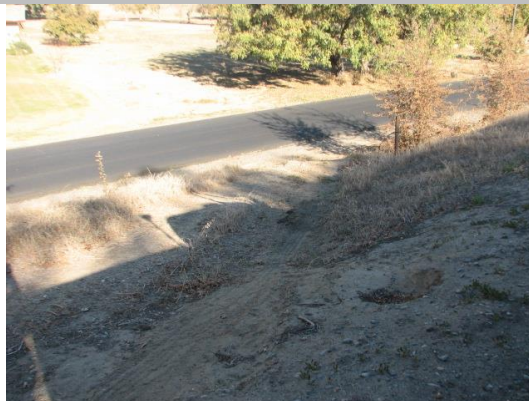
Photo 1 of 1 : SP_2015_RD1600_191_140_20150324_00045.jpg

LM Start	3.04	Rating **	M	Issue No.	140
LM End	3.04	Issue Type +	Ma	Location *	LS
Category	Earthen Levee			GPS Latitude/Longitude	
				Start	End
Item	Erosion / Bank Caving			38.711655 °	38.711655 °
				-121.613871 °	-121.613871 °
DWR ID	DWR_RD1600_01_f _ 2013_140				
Action/Comments					
Schedule repair of erosion site prior to the next inspection.

Erosion caused by vehicle traffic on the landside slope. Fall 2013

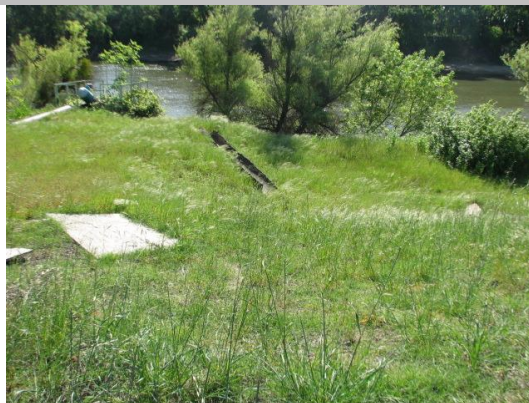
Photo 1 of 1 : SP_2015_RD1600_191_627_20150324_00051.jpg

Metal pipe and wood debris is on the waterside berm. Spring 2014

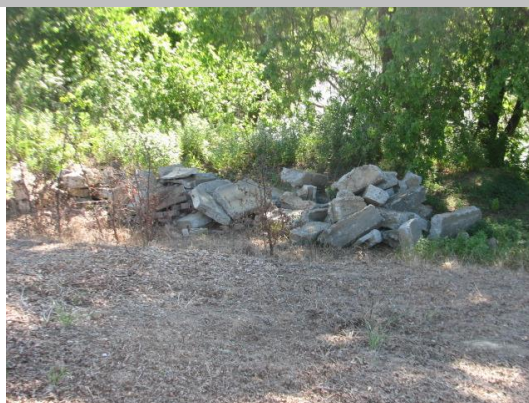
Photo 1 of 1 : SP_2015_RD1600_191_628_20150324_00052.jpg

Concrete debris is on the waterside berm. Spring 2014

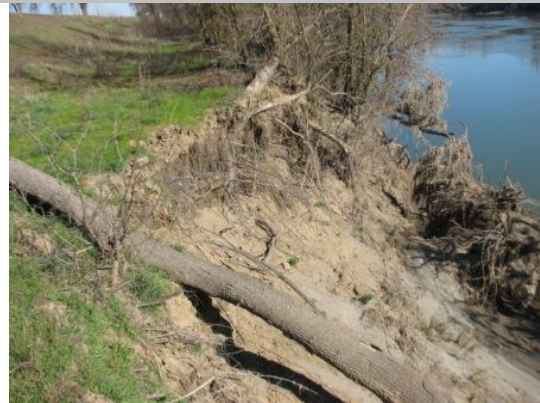
Photo 1 of 1 : SP_2015_RD1600_191_2_20150324_00002.jpg

Trees have fallen and the water has created the erosion into the berm.
Spring 2013

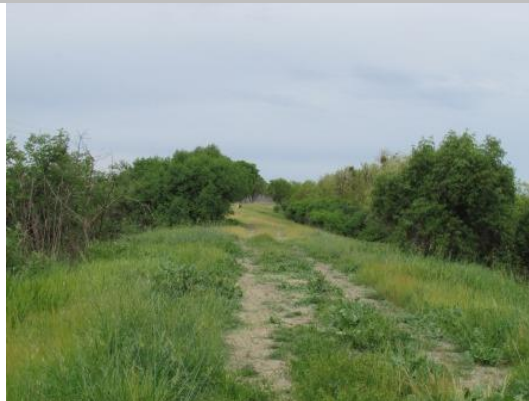
Photo 1 of 1 : SP_2015_RD1600_191_1193_20150326_00254.jpg

View of vegetation on the landward side of the levee looking upstream.
Spring 2015.

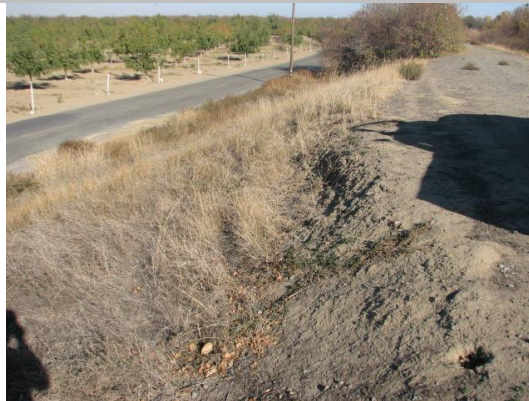
Photo 1 of 1 : SP_2015_RD1600_191_141_20150324_00046.jpg

LM Start	4.77	Rating **	M	Issue No.	141
LM End	4.77	Issue Type +	Ma	Location *	LS
Category	Earthen Levee			GPS Latitude/Longitude	
				Start	End
Item	Slope Stability			38.734840 °	38.734840 °
				-121.605026 °	-121.605026 °
DWR ID	DWR_RD1600_01_f_2013_141				
Action/Comments					
Repair slope instability.

The erosion at the shoulder of the levee could be slope instability. Fall
2013

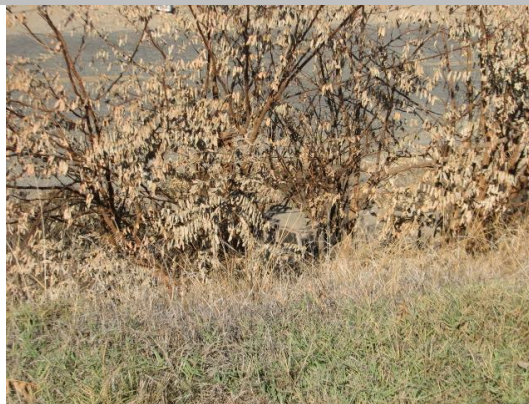
Photo 1 of 1 : SP_2015_RD1600_191_14_20150324_00015.jpg

Tree stumps on the levee slope has been sprayed. Fall 2013

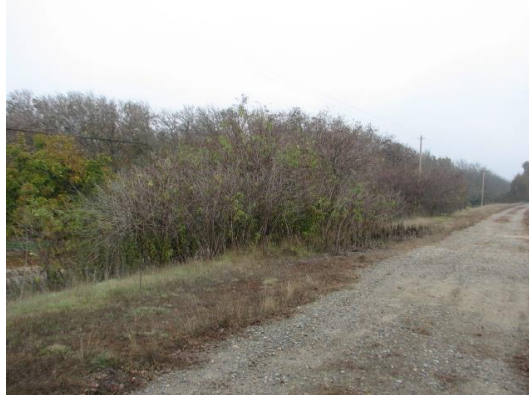
Photo 1 of 1 : SP_2015_RD1600_191_13_20150324_00014.jpg

A thick stand of elderberries on the landside. Fall 2012

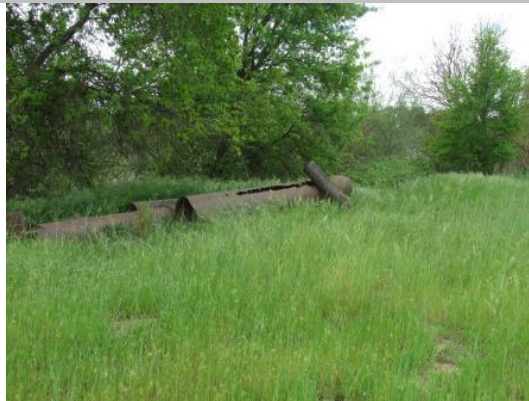
Photo 1 of 1 : SP_2015_RD1600_191_1198_20150326_00255.jpg

View of debris on the waterward side of the levee looking downstream.
Spring 2015.

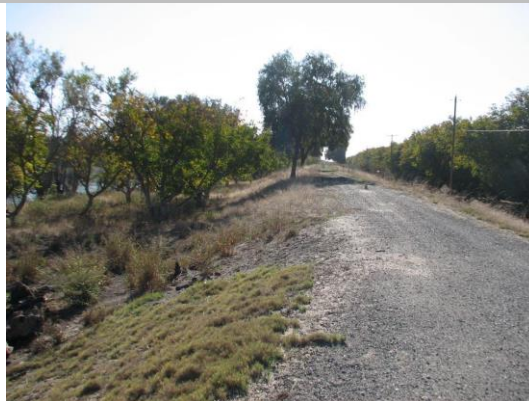
Photo 1 of 2 : SP_2015_RD1600_191_40_20150324_00035.jpg

Levee mile 5.80, vegetation on the water side slope.

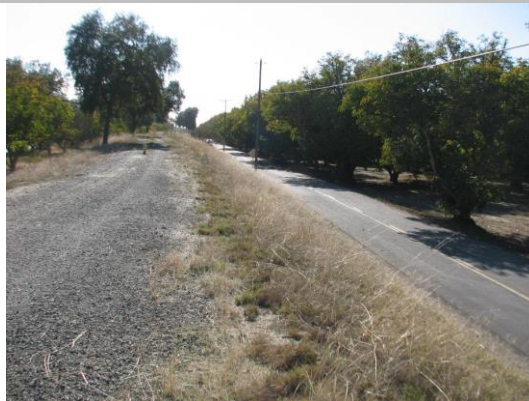
Photo 2 of 2 : SP_2015_RD1600_191_40_20150324_00036.jpg

Levee mile 5.80, vegetation on the land side slope.

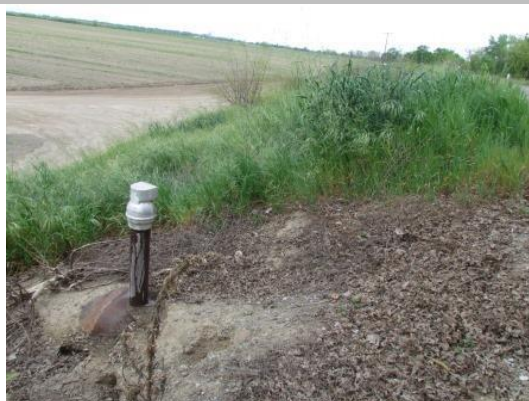
Photo 1 of 1 : SP_2015_RD1600_191_1199_20150326_00256.jpg

View of erosion and pipe on the landward side of the levee looking upstream. Spring 2015.

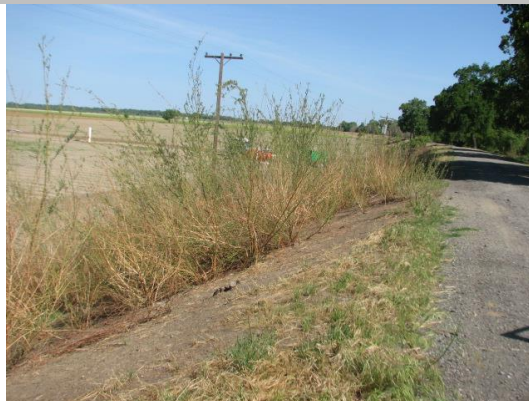
Photo 1 of 1 : SP_2015_RD1600_191_631_20150324_00054.jpg

The tall brush and vegetation blocks visibility. Spring 2014

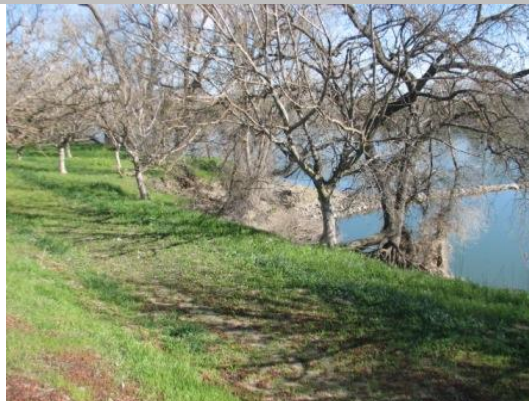
Photo 1 of 1 : SP_2015_RD1600_191_30_20150324_00029.jpg

Erosion is into the berm area and needs to be monitored. Spring 2013

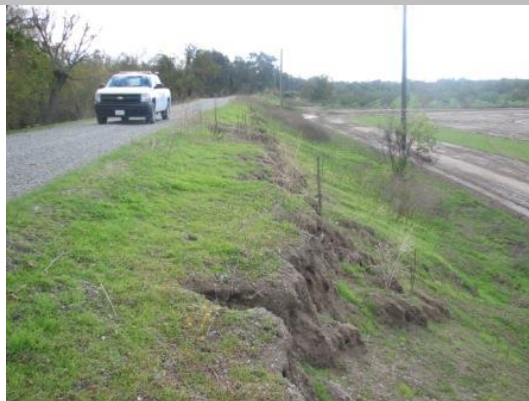
Photo 1 of 1 : SP_2015_RD1600_191_27_20150324_00026.jpg

The erosion appears to be moving closer to the shoulder.

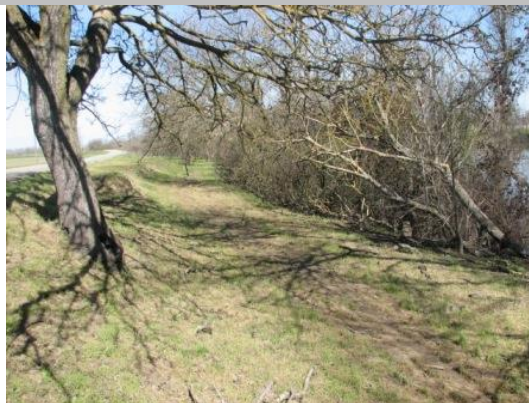
Photo 2 of 2 : SP_2015_RD1600_191_20_20150324_00019.jpg

The erosion is eroding away at the berm area.

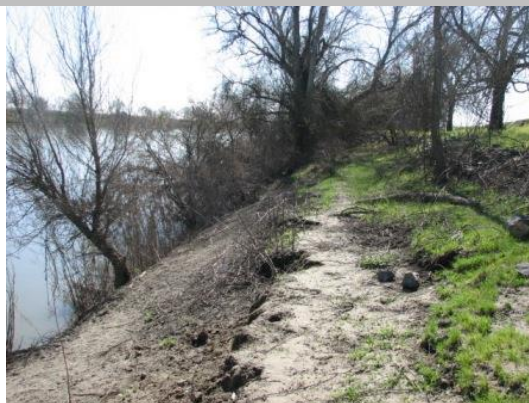
Photo 1 of 2 : SP_2015_RD1600_191_21_20150324_00020.jpg

The erosion is eroding away the berm area.

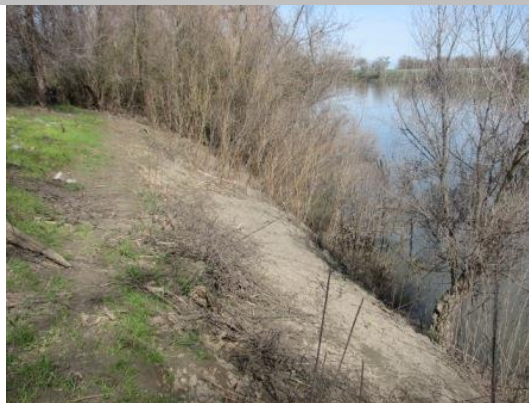
Photo 2 of 2 : SP_2015_RD1600_191_21_20150324_00021.jpg

The bank is eroding away and has become very steep.

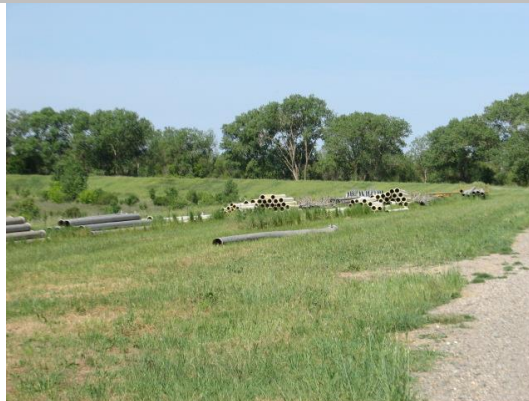
Photo 1 of 1 : SP_2015_RD1600_191_634_20150324_00055.jpg

Irrigation pipe is being stored on the landside. Spring 2014

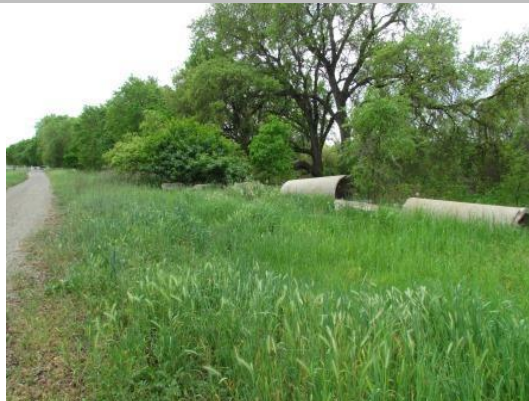
Photo 1 of 1 : SP_2015_RD1600_191_1202_20150326_00257.jpg

View of debris on the waterward side of the levee looking upstream.
Spring 2015.

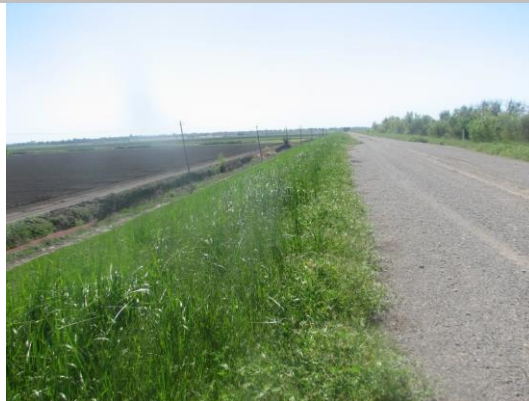
Photo 1 of 1 : SP_2015_RD1600_192_290_20150326_00020.jpg

View of vegetation on the landward side of the levee looking downstream. Spring 2015.

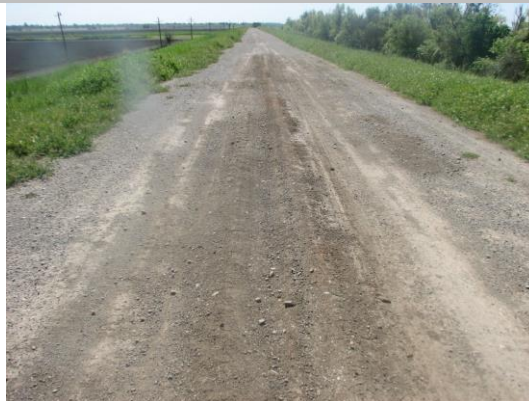
Photo 1 of 1 : SP_2015_RD1600_192_292_20150326_00021.jpg

View of depression on the crown of the levee looking downstream. Spring 2015.

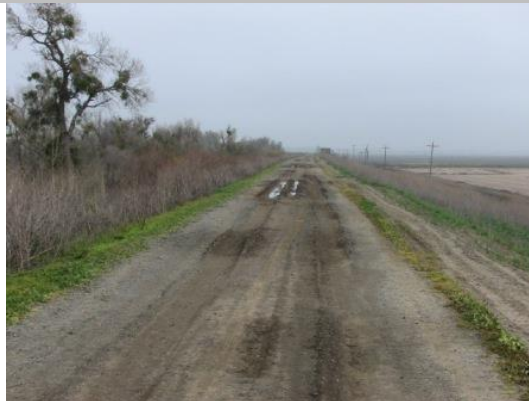
Photo 1 of 1 : SP_2015_RD1600_192_11_20150324_00008.jpg

This area is soft and needs to have AB added to make an all weather surface.

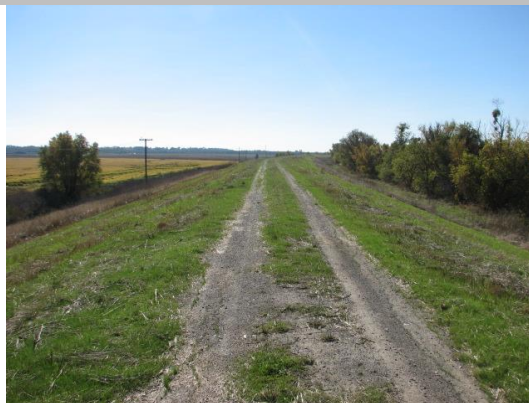
Photo 1 of 2 : SP_2015_RD1600_192_31_20150324_00013.jpg

The crown of the levee needs to be weed free. Fall 2012

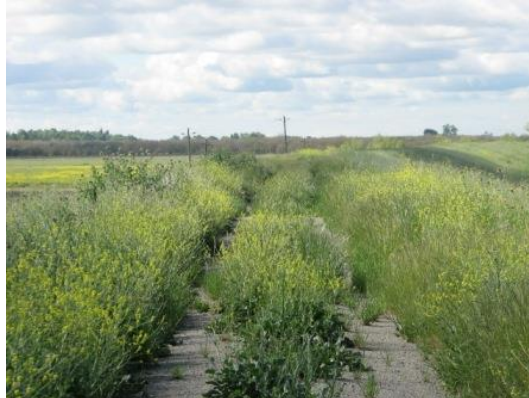
Photo 2 of 2 : SP_2015_RD1600_192_31_20150324_00014.jpg

The crown roadway needs to be free of weeds. Photo taken spring 2012.

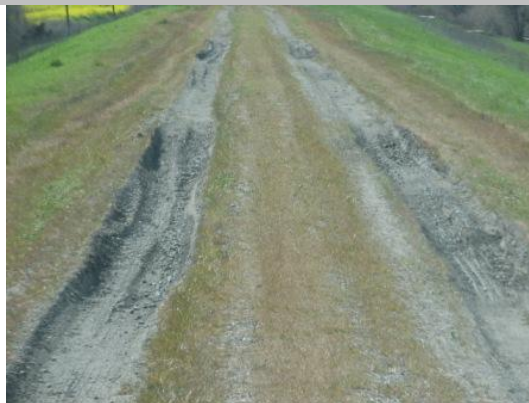
Photo 1 of 2 : SP_2015_RD1600_192_6_20150324_00003.jpg

Ruts in the levee crown. Spring 2013

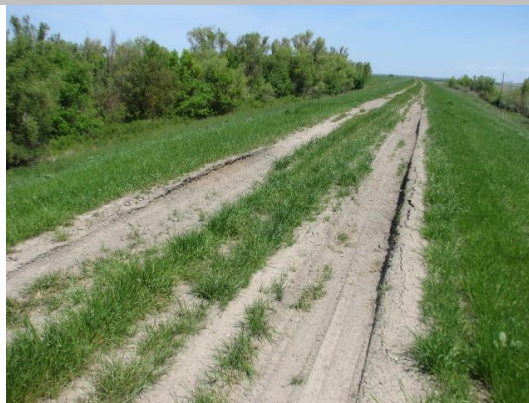
Photo 2 of 2 : SP_2015_RD1600_192_6_20150324_00004.jpg

Ruts in the all weather road need to be repaired. Spring 2014

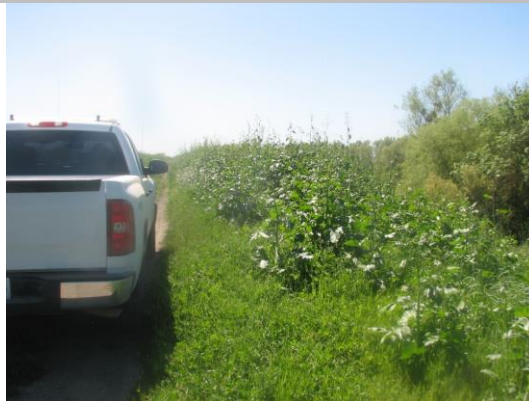
Photo 1 of 1 : SP_2015_RD1600_192_4_20150326_00022.jpg

View of vegetation on the waterward side of the levee looking downstream. Spring 2015.

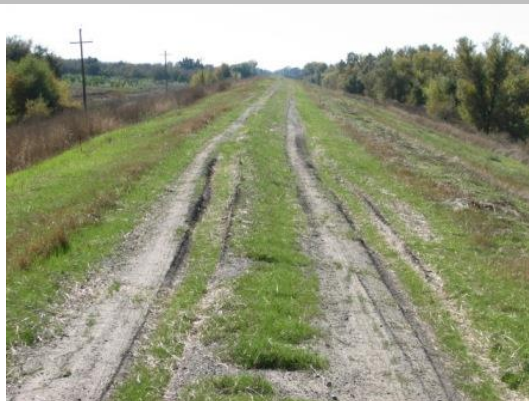
Photo 1 of 3 : SP_2015_RD1600_192_32_20150324_00015.jpg

The crown has ruts deeper then six inches. Fall 2012

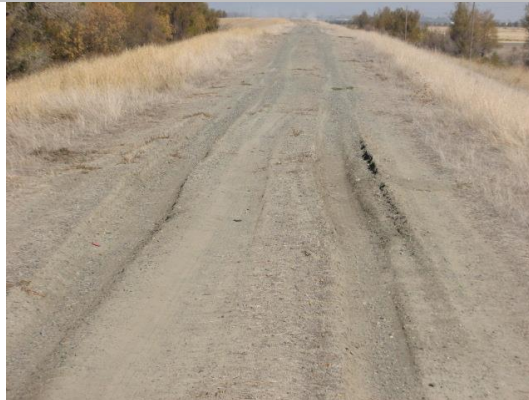
Photo 2 of 3 : SP_2015_RD1600_192_32_20150324_00016.jpg

Tire ruts are deeper than 6 inches on the crown. Fall 2013

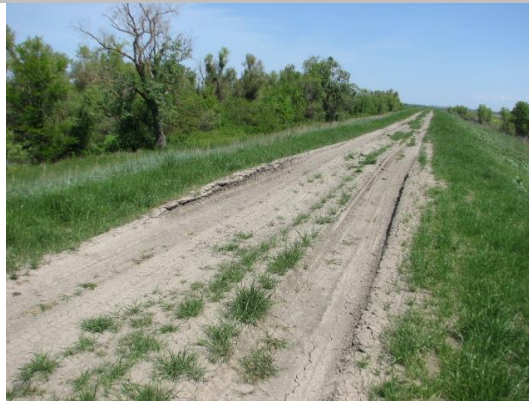
Photo 3 of 3 : SP_2015_RD1600_192_32_20150324_00017.jpg

Ruts in the all weather road needs to be repaired. Spring 2014

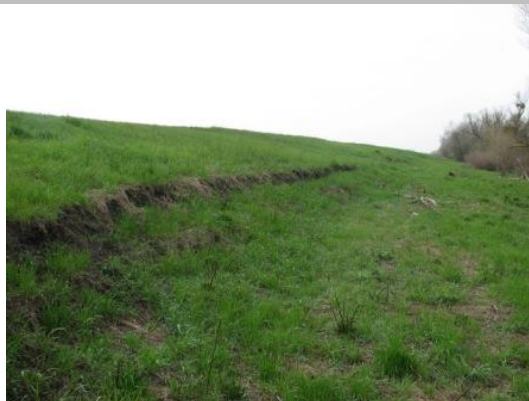
Photo 1 of 2 : SP_2015_RD1600_192_14_20150324_00009.jpg

A closer view of the wave wash damage along the bypass.

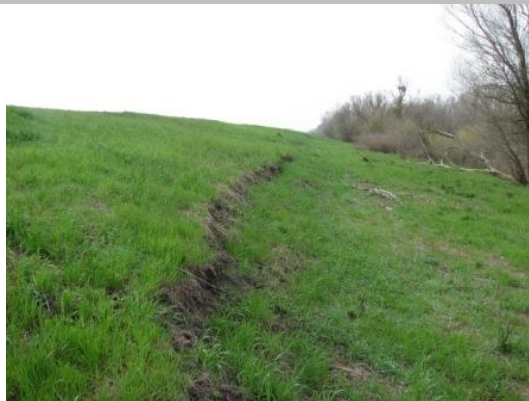
Photo 2 of 2 : SP_2015_RD1600_192_14_20150324_00010.jpg

Wave wash damage along the slope the cut is 1'-2'.

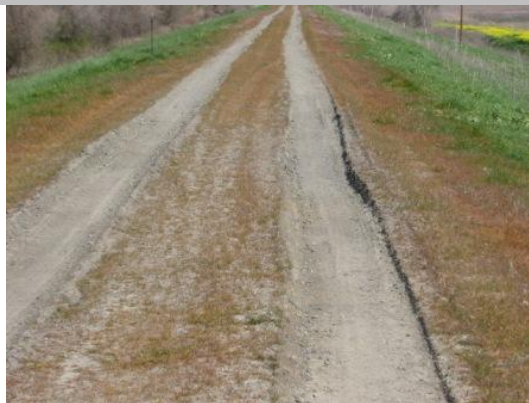
Photo 1 of 3 : SP_2015_RD1600_192_7_20150324_00005.jpg

Ruts in the levee crown. Spring 2013

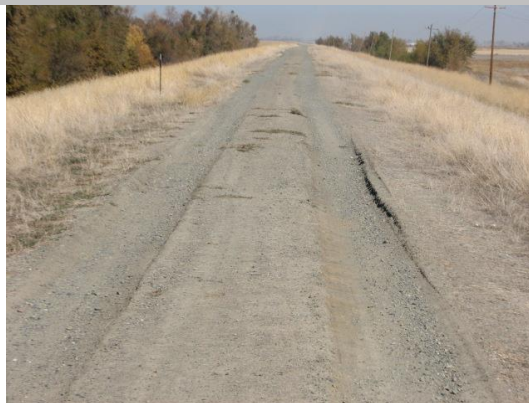
Photo 2 of 3 : SP_2015_RD1600_192_7_20150324_00006.jpg

Tire ruts are deeper than 6 inches on the crown. Fall 2013

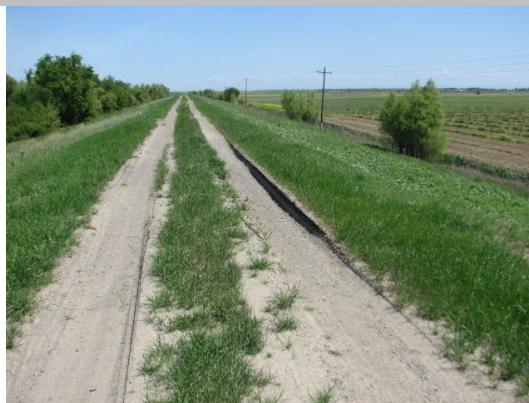
Photo 3 of 3 : SP_2015_RD1600_192_7_20150324_00007.jpg

Ruts in the all weather road needs to be repaired. Spring 2014

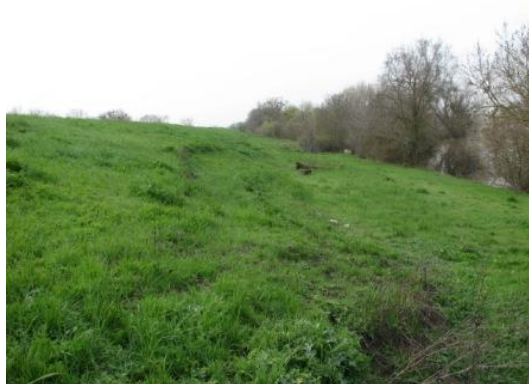
Photo 2 of 2 : SP_2015_RD1600_192_15_20150324_00012.jpg

This is wave wash damage along the toe of the levee looking downstream.

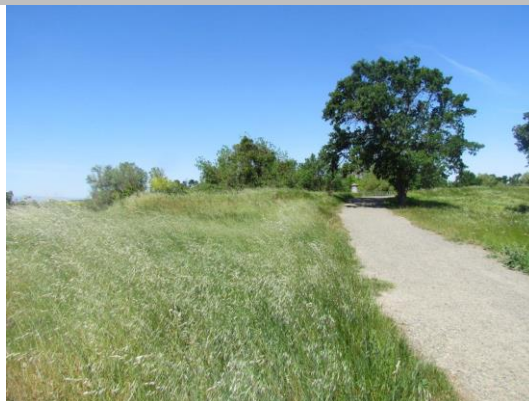
Photo 1 of 1 : SP_2015_RD1600_192_297_20150415_00023.jpg

View of the vegetation on the waterward side of the levee looking upstream. Spring 2015

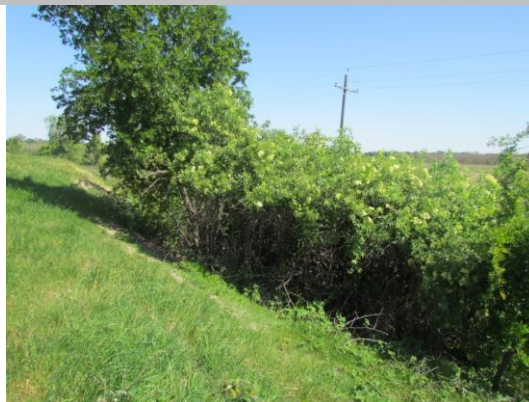
Photo 1 of 1 : SP_2015_RD1600_192_299_20150417_00024.jpg

View of the elderberry on the landward side of the levee looking upstream. Spring 2015.
